KENTUCKY HISTORIC RESOURCES  
INDIVIDUAL SURVEY FORM  
(KHC 2002-1)

COUNTY Lewis  
RESOURCE # Lw-84  
RELATED GROUP #  
EVALUATION S  
SHPO EVALUATION S  
DESTROYED

1. NAME OF RESOURCE (how determined): 9 / House

2. ADDRESS/LOCATION:  
HC 73 Box 1165, Old KY Highway 10  
Charters, KY. 41179

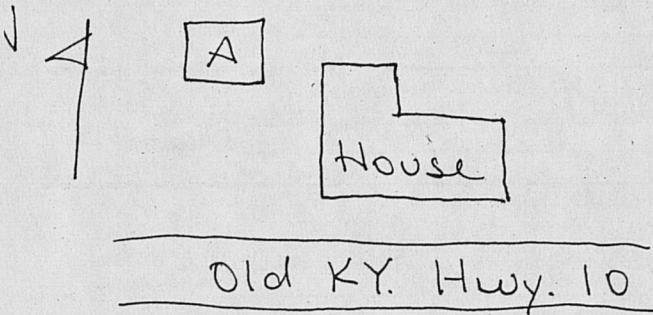
26. SITE PLAN (Complete if #25 was answered).

25. SUPPORT RESOURCES:	<u>SITE PLAN KEY</u>	<u>FUNCTION</u>	<u>CONSTRUCTION DATE</u>	<u>METHOD MATERIAL</u>
	A	Shed/ Garage	c. 1940's	W/3/ Frame (Vertical siding)
